Written Warning

No. 2-006607

ASH GROVE CEMENT COMPANY

Re: Written Warning 2-006607

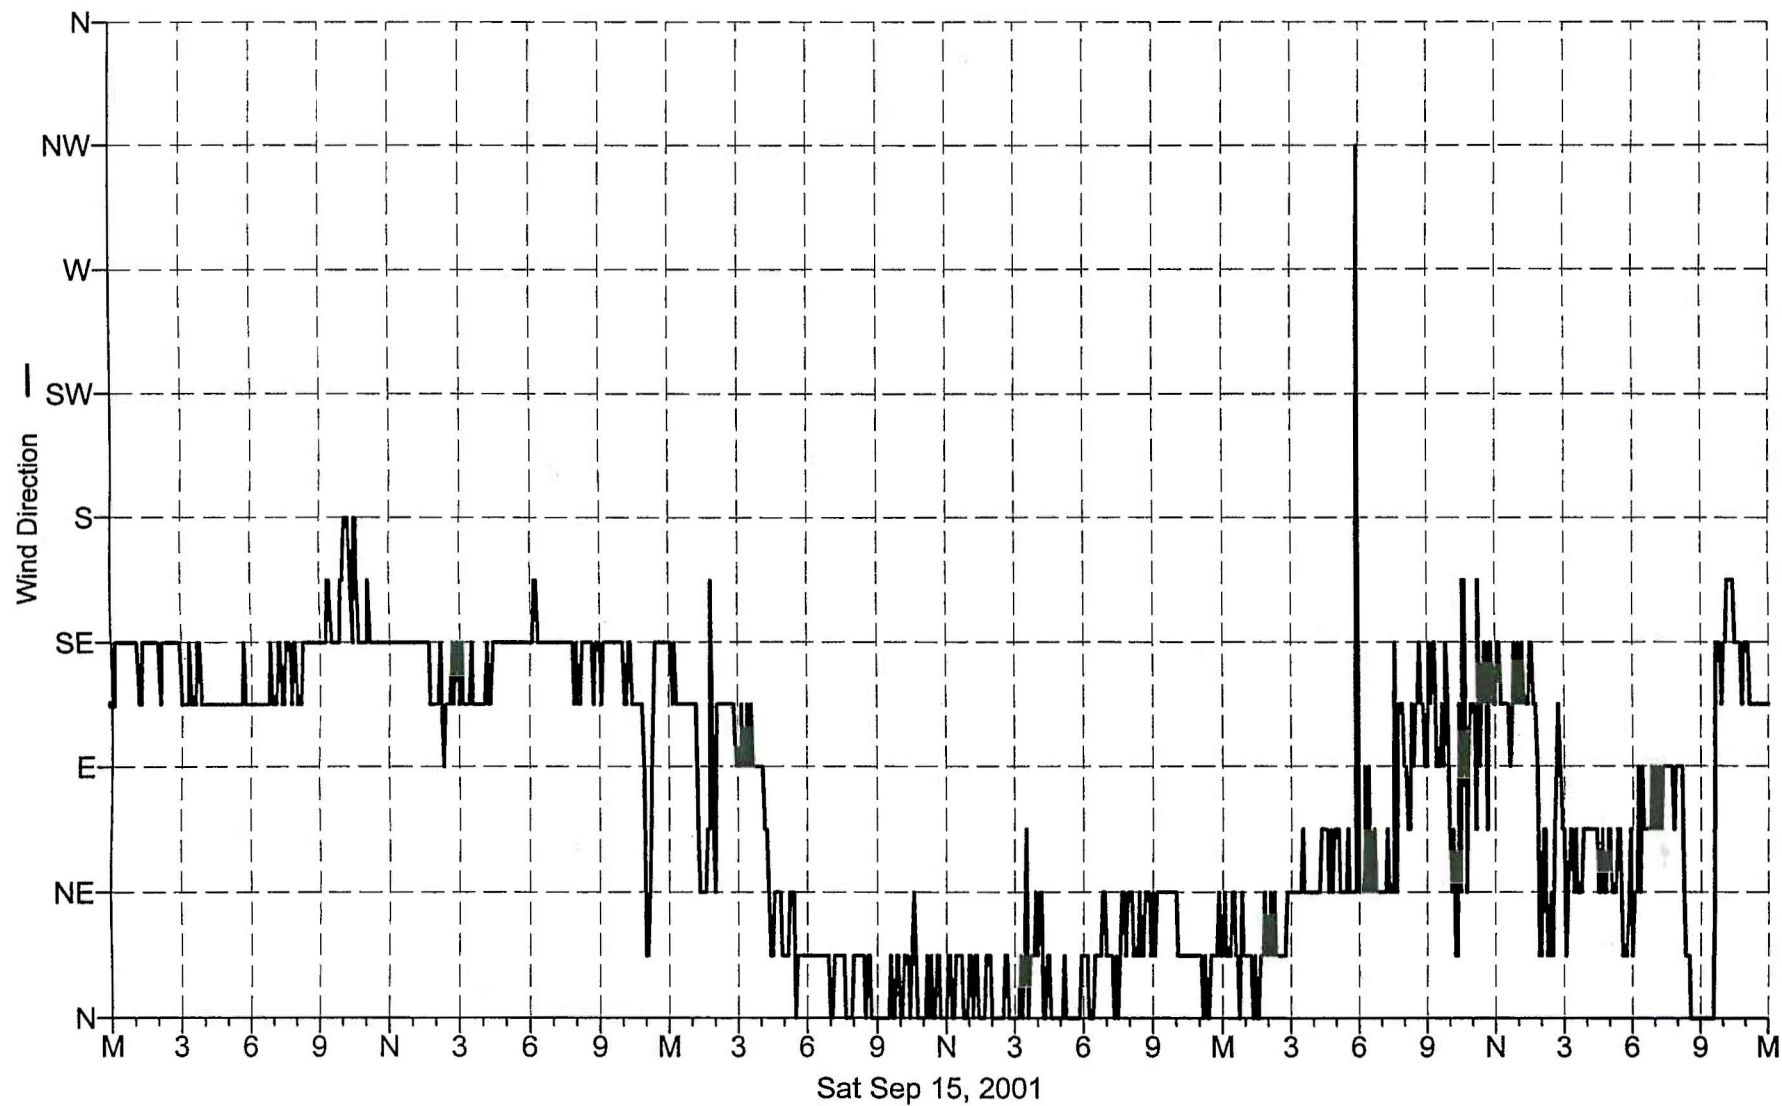
GP2

The attached is weather data from our plant station for the entire month of September 2001 and for the period in question. This wind data identifies wind direction by its heading (the direction the wind was blowing) rather than by its direction of origin. Our data agrees with the Agency's data showing the wind for this period was blowing toward the southeast on 9/15, north northeast on 9/16 and northeast on 9/17. Also included is the wind graph showing that the wind direction was fairly consistent for these days. Given these wind directions, the above facilities could not have effected by plant activity as claimed.
